...NWS Damage Survey for 04/16/23 Micco Tornado Event...

.Micco EF-0 Tornado...

Rating:	EF-0
Estimated Peak Wind:	65-75 mph
Path Length /statute/:	0.50 miles
Path Width /maximum/:	100 yards
Fatalities:	0
Injuries:	0
Start Date:	Apr 16 2023
Start Time:	536 pm EDT
Start Location:	1 ENE Micco
Start Lat/Lon:	27.8749 / -80.5040
End Date:	Apr 16 2023
End Time:	538 pm EDT
End Location:	1 ENE Micco
End Lat/Lon:	27.8727 / -80.4965

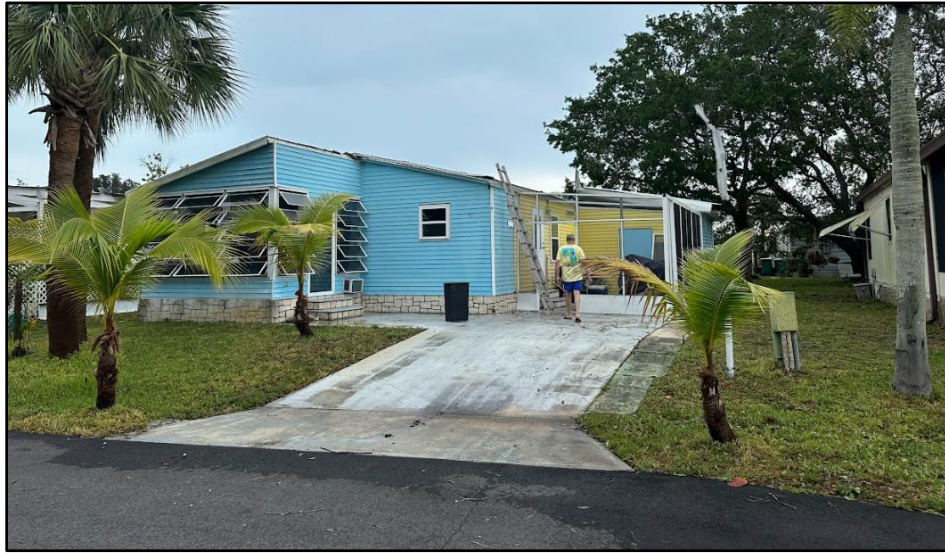
Figure 1. Damage to a home on Love Ct. in the River Grove community in Micco, FL. (Photo: Robert Haley)

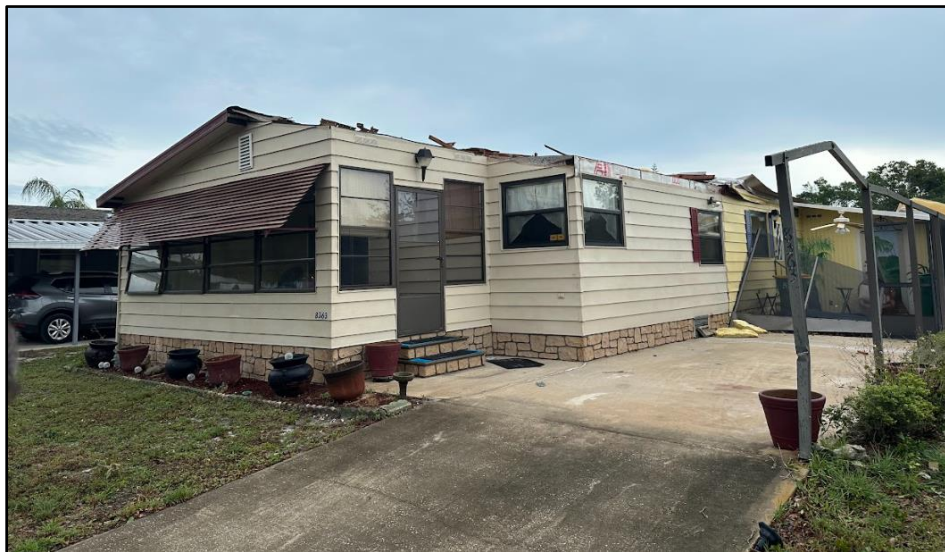
Figure 2. Damage to a home on Love Ct. in the River Grove community in Micco, FL. (Photo: Robert Haley)

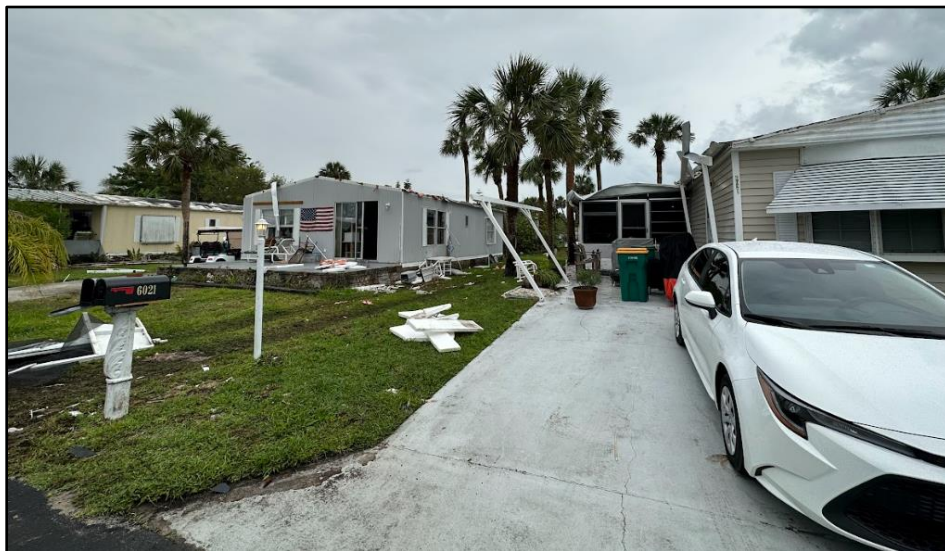
Figure 3. Damage to a home on River Grove Dr. in the River Grove community in Micco, FL. (Photo: Robert Haley)

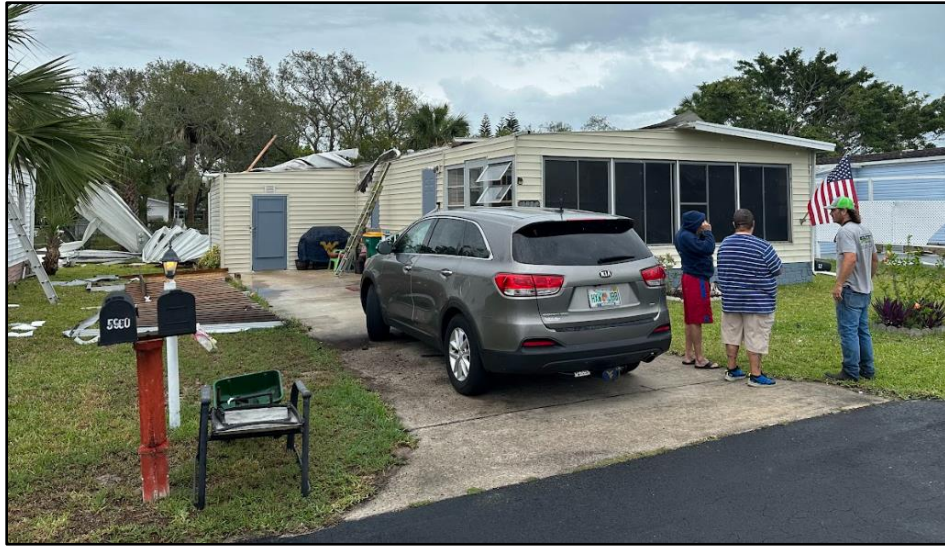
Figure 4. Damage to a home on River Grove Dr. in the River Grove community in Micco, FL. (Photo: Robert Haley)

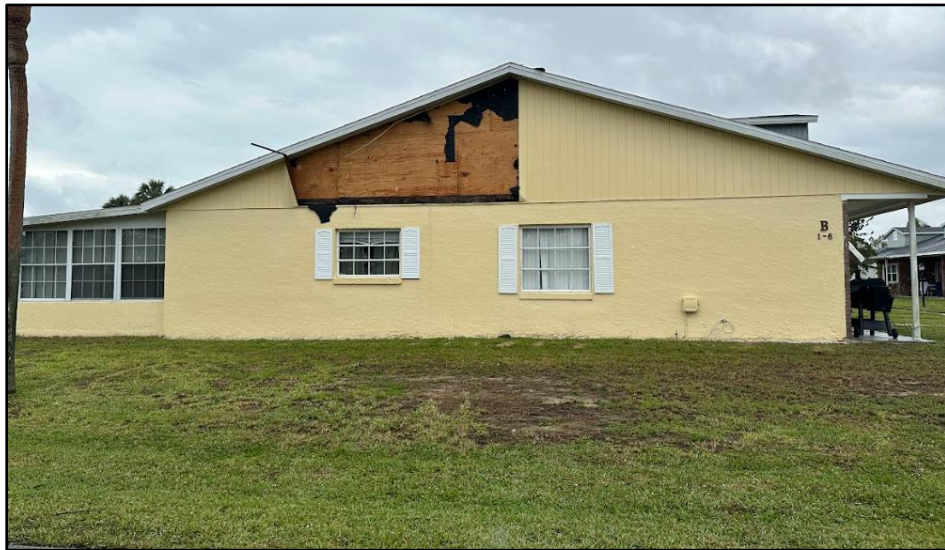
Figure 5. Damage to the side of a condominium on Summit Cove Dr. in the Summit Cove community in Micco, FL. (Photo: Robert Haley)

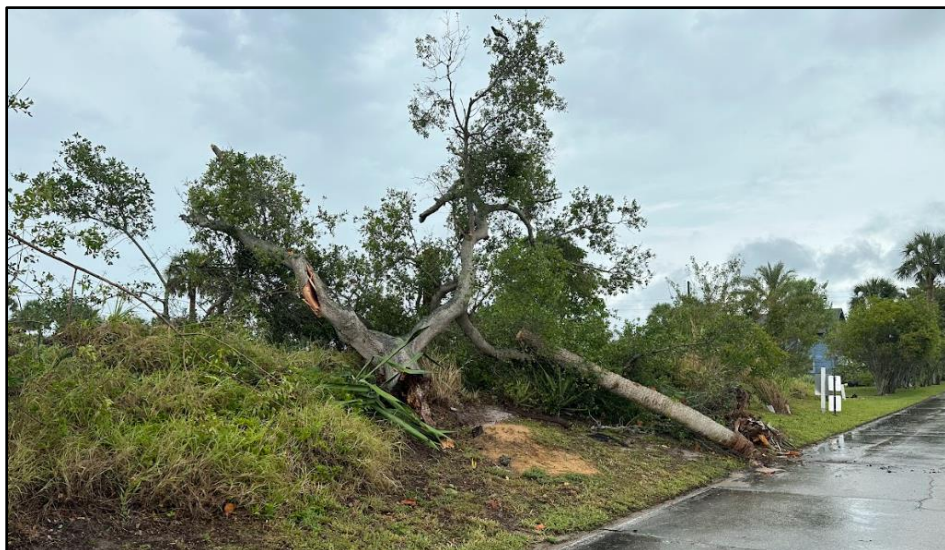
Figure 6. Fallen trees along Summit Cove Dr. in the Summit Cove community in Micco, FL. (Photo: Robert Haley)
